**NASA Technical Memorandum 87603**

**FAILURE MECHANISMS OF LAMINATES TRANSVERSELY LOADED  
BY BOLT PUSH-THROUGH**

✓  
**WILLIAM ALLEN WATERS, JR. AND JERRY G. WILLIAMS**

SEPTEMBER 1985

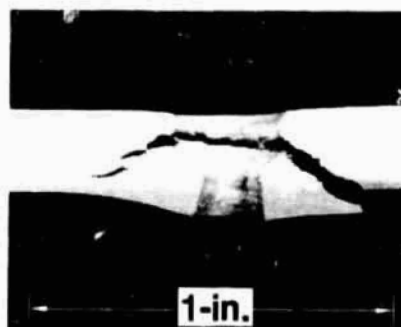
FIGURE 23. Bolt push-through failure modes for aluminum.

(a) 1-inch boundary.

(b) 2-inch boundary.

Aluminum Specimens. Failure modes for the two aluminum alloys are shown in Figure 23. Rolling during processing causes the grain structure of 7075-T651 aluminum to be elongated in the roll direction which produces a banded or multi-layered microstructure. This microstructure results in a non-isotropic material that exhibits the stair-step failure pattern shown. With less grain elongation the 2024-T4 aluminum is more isotropic in behavior and failure occurs as a result of the shear-out of a plug approximately the size of the bolt head.
